Evaluation of fiber optic installation methods, a case study on micro-trenching in Alberta, Canada

Hediyeh Vaseli^a, Leila Hashemian^a, Alireza Bayat^{a*}, Leon Gay^b, Ian Williams^c, and Jordan Melzer^d

Abstract

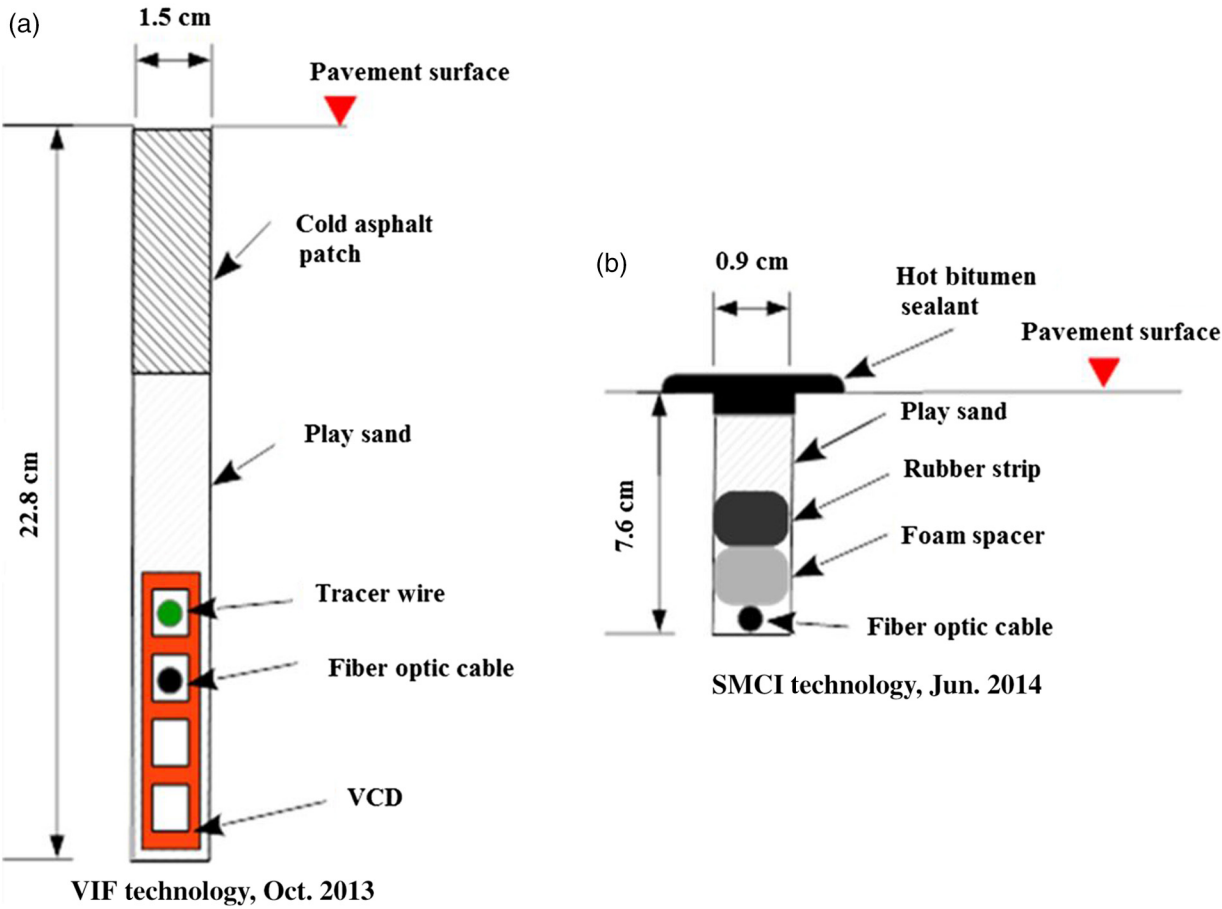
Fig. 3. Cross section of (a) vertical inlaid fiber (VIF) and (b) surface micro-cable inlay (SMCI) installations.

Installation specifications for the VIF technology and a cross section of the SMCI technology are provided in [Table 1](#) and [Fig. 3](#), respectively.

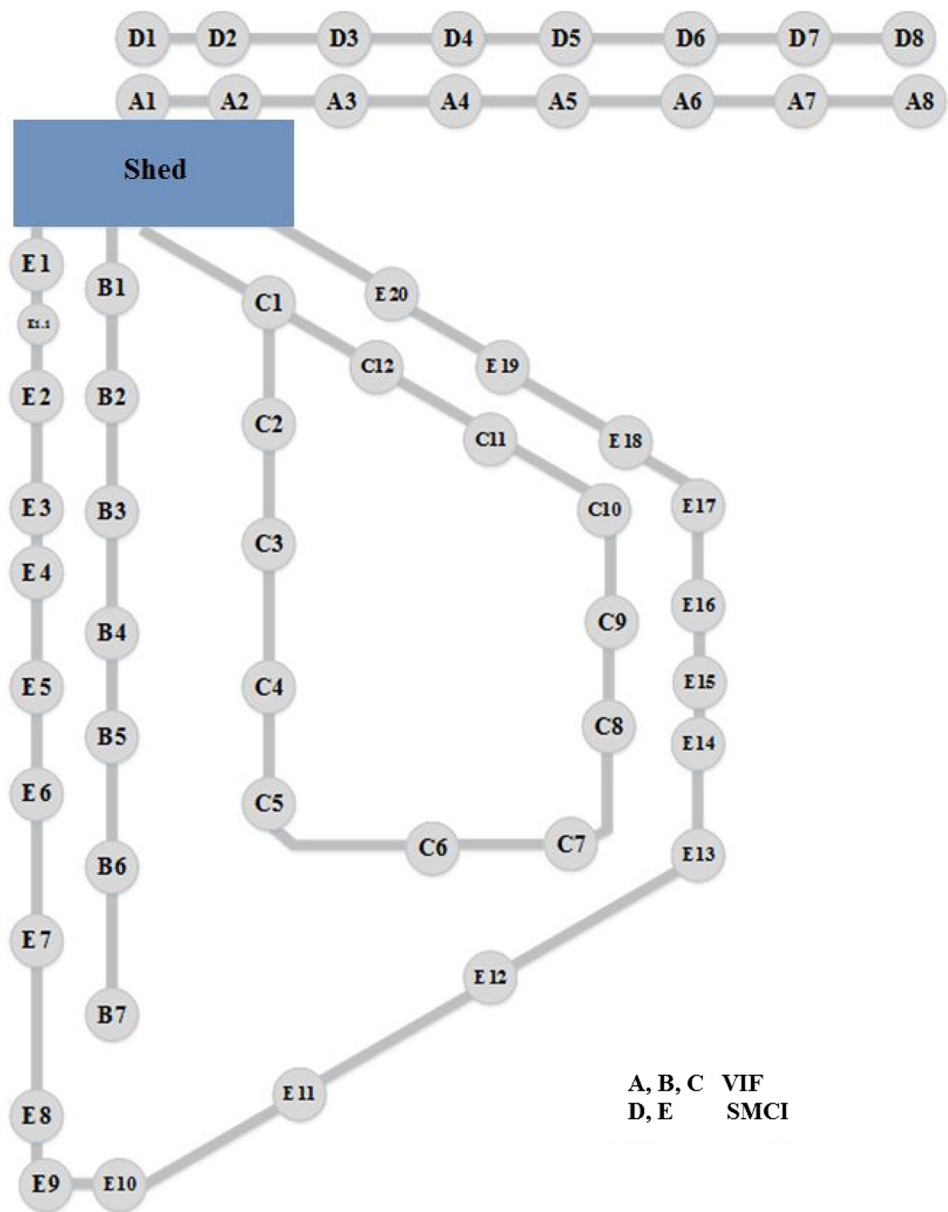
Fig. 5. Ground-penetrating radar-inspected points in vertical inlaid fiber (VIF) and surface micro-cable inlay (SMCI) installations.

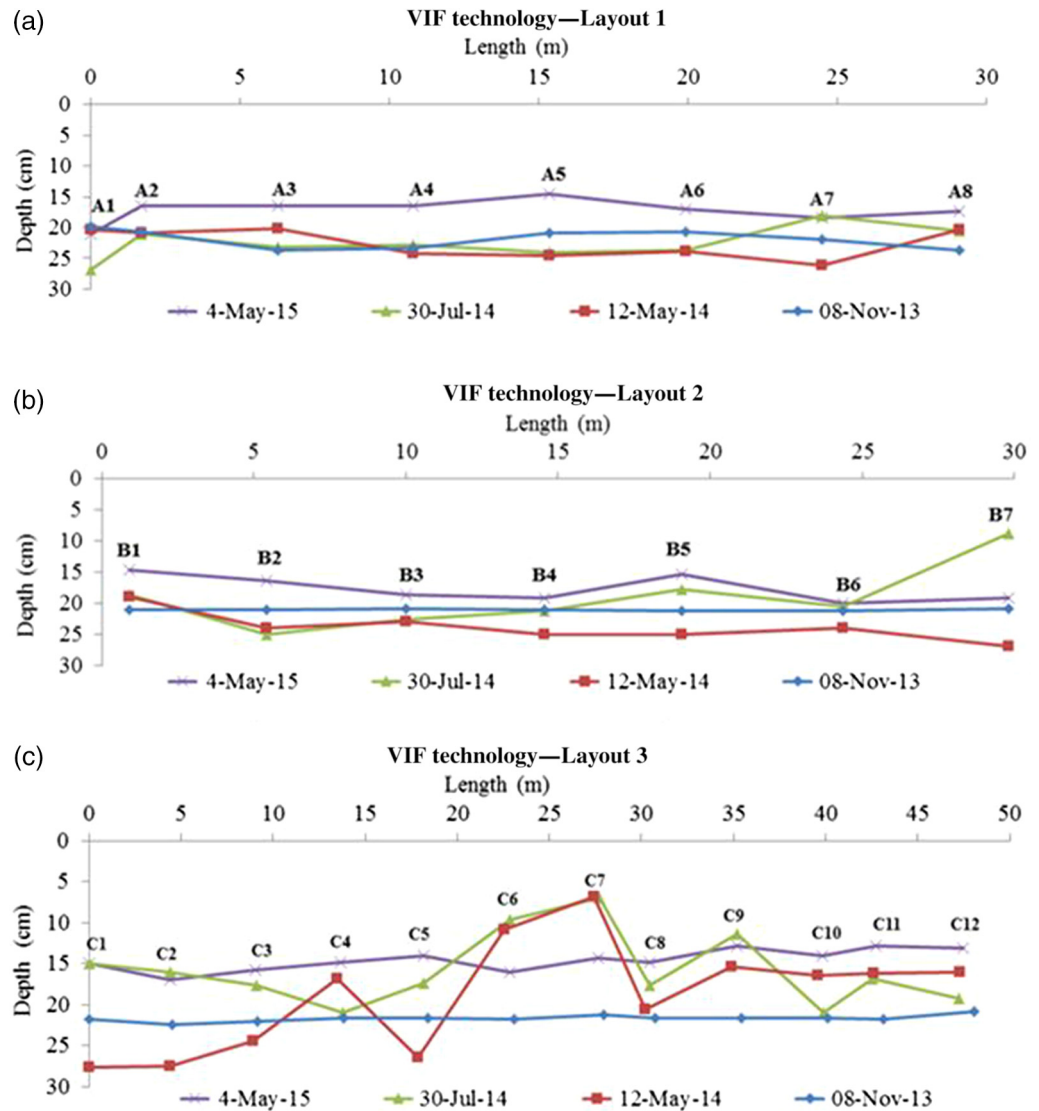
Fig. 6. Conduit profile for vertical inlaid fiber (VIF) technology: (a) Layout 1(A), (b) Layout 2(B), and (c) Layout 3(C).

To investigate the physical integrity of the installation, conduit location was detected using GPR. **Figures 6a–6c** show the conduit profile of Layouts 1(A), 2(B), and 3(C) for VIF technology. It must be noted that the conduit profile was obtained using its depth relative to the surface. In Layout 3(C), the loop is unfolded, and the conduit profile is provided. Points C5, C7, and C10 were located in the bends of the layout (the intersection of straight lines).

Figures 6a and **b** show that both Layouts 1 and 2 were in relatively good condition with little vertical displacement toward the surface, except at point B7, which had a shallow depth of 8.8 cm according to

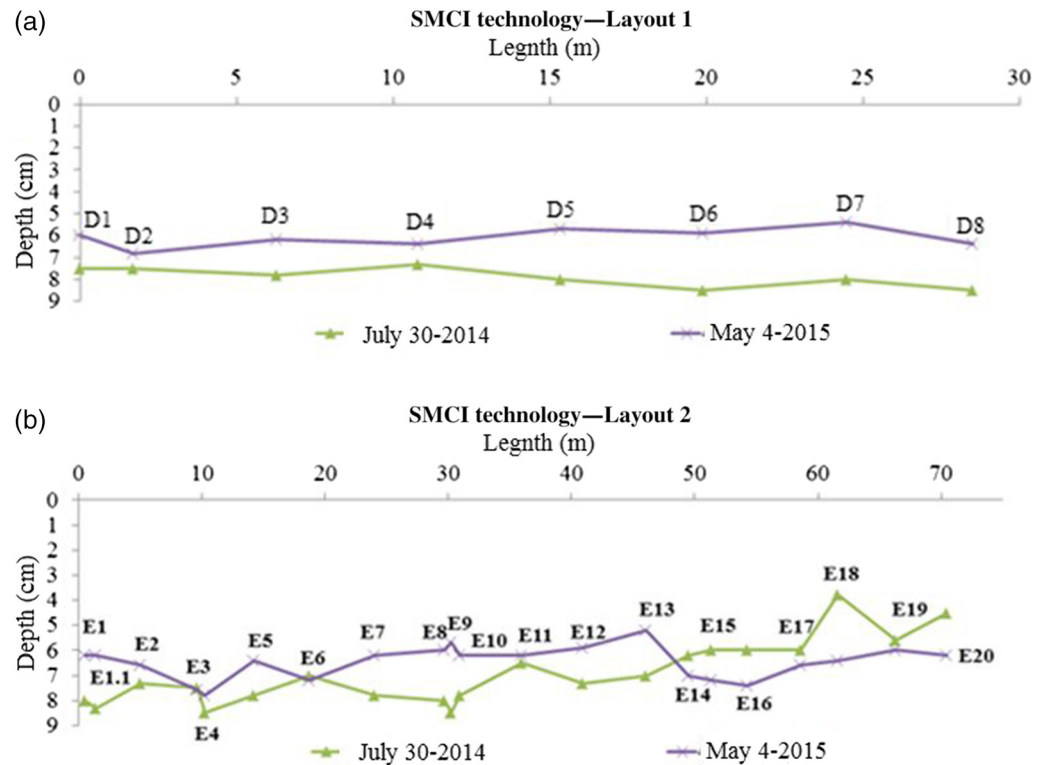
Fig. 7. Conduit profile for SMCI technology: (a) Layout 1(D) and (b) Layout 2(E).

Figures 7a and **b** show the conduit profile of Layouts 1(D) and 2(E) for SMCI technology. It must be noted that the conduit profile was obtained using its depth relative to the surface. In Layout 2(E), the loop is unfolded, and the conduit profile is provided. Points E9, E10, E13, and E17 were located in the bends of the layout (the intersection of straight lines).
