Evaluation of fiber optic installation methods, a case study on micro-trenching in Alberta, Canada

Hediyeh Vaseli^a, Leila Hashemian^a, Alireza Bayat^{a*}, Leon Gay^b, Ian Williams^c, and Jordan Melzer^d

^aDepartment of Civil and Environmental Engineering, University of Alberta, Edmonton, AB T6G 2W2, Canada; ^bDepartment of Civil and Environmental Engineering, Universidad de Guanajuato, 36020 Guanajuato, Mexico; ^cAccess Technologies & Outside Plant Support (ATOPS), TELUS Communications, Sherwood Park, AB T8A 2X2, Canada; ^dChief Technology Office, TELUS Communications, Ottawa, ON K1P 0A6, Canada

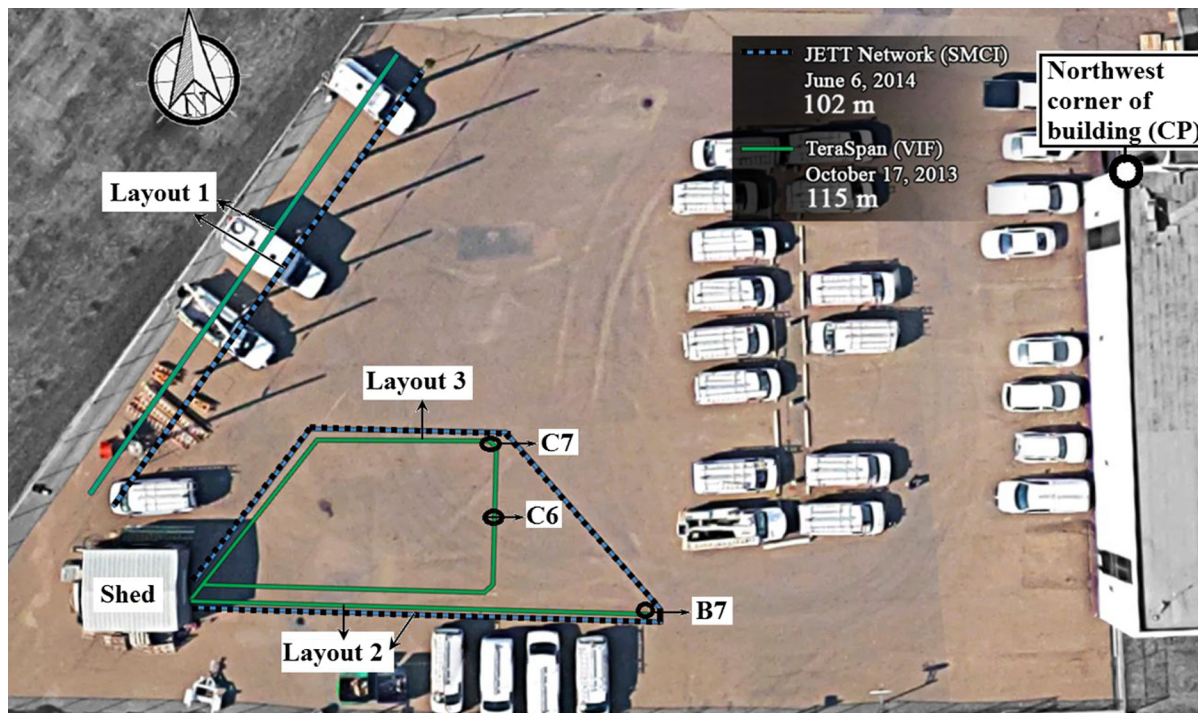
Fig. 1. Installation layouts, control point (CP), and shallowest points (C7, C6, and B7).

Two micro-trenching technologies, vertical inlaid fiber (VIF) and surface micro-cable inlay (SMCI), were used for installation in this experiment. The test installation was located at 2920 66 St NW, Edmonton, Alberta, in a parking lot belonging to a TELUS Communications operational building. TeraSpan conducted the first installation VIF on 17 October 2013. JETT Networks conducted the second installation SMCI on 6 June 2014. Details of the installation layouts ([Fig. 1](#)) are as follows:

- VIF technology
 1. 30 m straight layout without traffic load
 2. 30 m straight layout located in the direct path of traffic
 3. 55 m loop layout located in the direct path of traffic
- SMCI technology
 1. 30 m straight layout without traffic load
 2. 72 m loop layout in the direct path of traffic

the GPR inspection in July 2014. However, it moved downward and now has a depth of 19 cm according to a recent GPR inspection. In addition, in the northeast corner of Layout 3 (loop layout), the conduit depth was significantly shallower than its initial depth in July 2014. In Fig. 6c, it can be seen that C7 and C6, with respective depths of 7 and 9.7 cm according to the GPR inspection in July 2014, were the shallowest points of the conduit profile in Layout 3 and had respective approximate displacements of 14 and 12 cm toward the surface. However, C6 and C7 moved downward and their current depths are 16 and 14 cm, respectively, according to recent GPR inspections. These three points (C6, C7, and B7) were in a more direct path of traffic compared with other points, as depicted in Fig. 1.

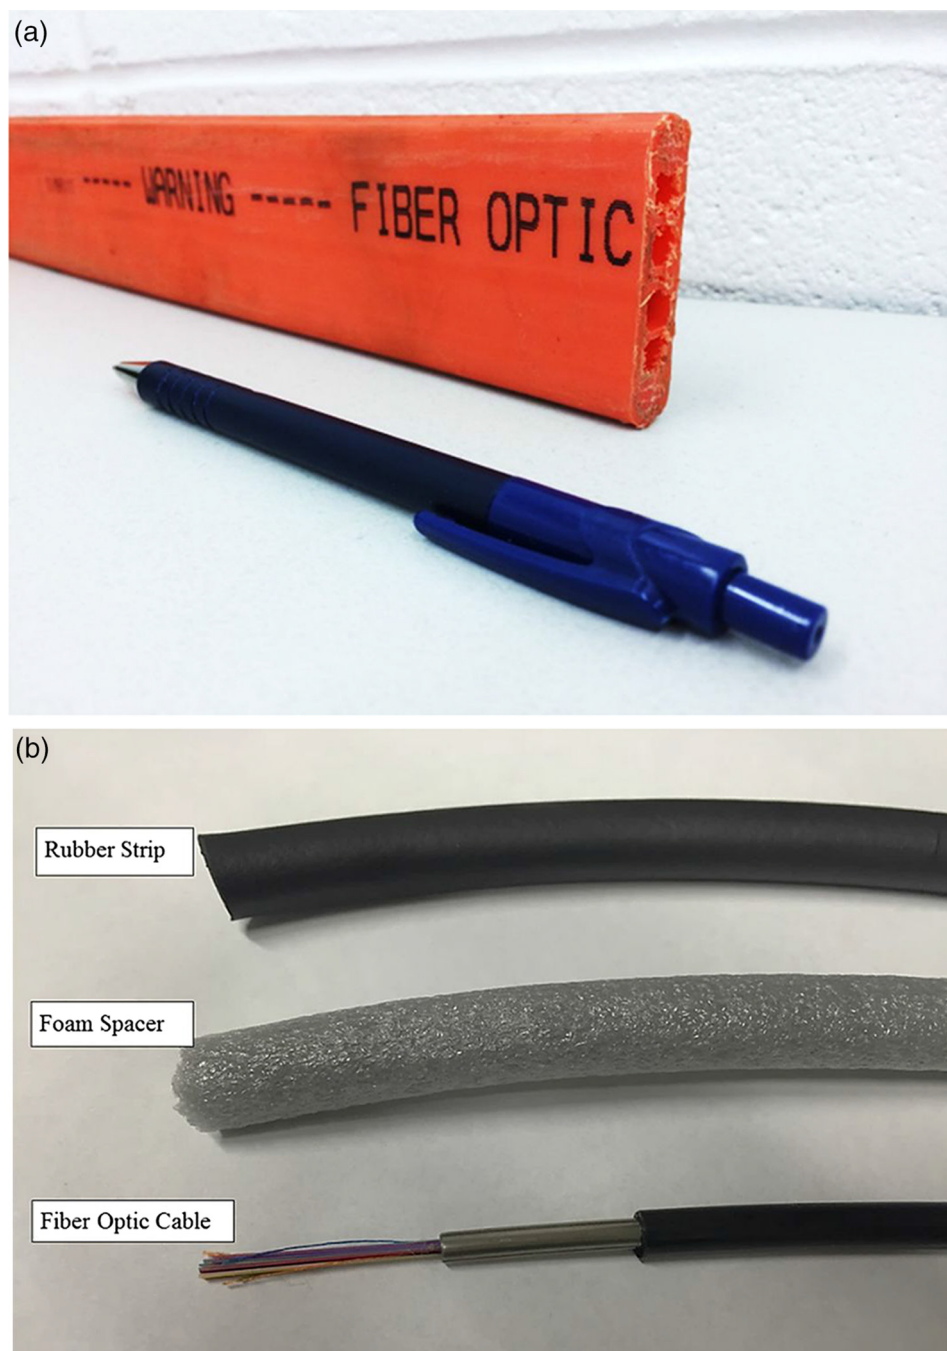
Fig. 2. (a) Vertical deflecting conduit, and (b) surface micro-cable inlay cable, foam spacer, and rubber strip.

This technology uses vertical deflecting conduit (VDC) ([Fig. 2a](#)), which consists of two robust, slim conduit halves fastened together by a zipper tool to form a channel that encloses the FO cable. FO cables can be zipped, pulled, or blown into the conduits ([TeraSpan 2013](#)).

The installation procedure for SMCI technology begins similarly to VIF; once measured, the layout is marked using a thread and spray paint. The trench is wet cut using a Husqvarna FS 4800 D. A vacuum and blower are then used to clean and dry the trench. With this technology, cable installation consists of three phases: laying FO cable in the trench, placing a layer of foam spacer over the cable, and placing a rubber strip over the spacer to secure the cable and foam spacer in the trench. The spacer is round and made from flexible closed cell foam to deter movement caused by freeze/thaw cycles and protect the cable from moisture and water ingress. The rubber strip is a heat- and chemical-resistant neoprene that holds and fixes the cable and foam spacer in place (Fig. 2b).

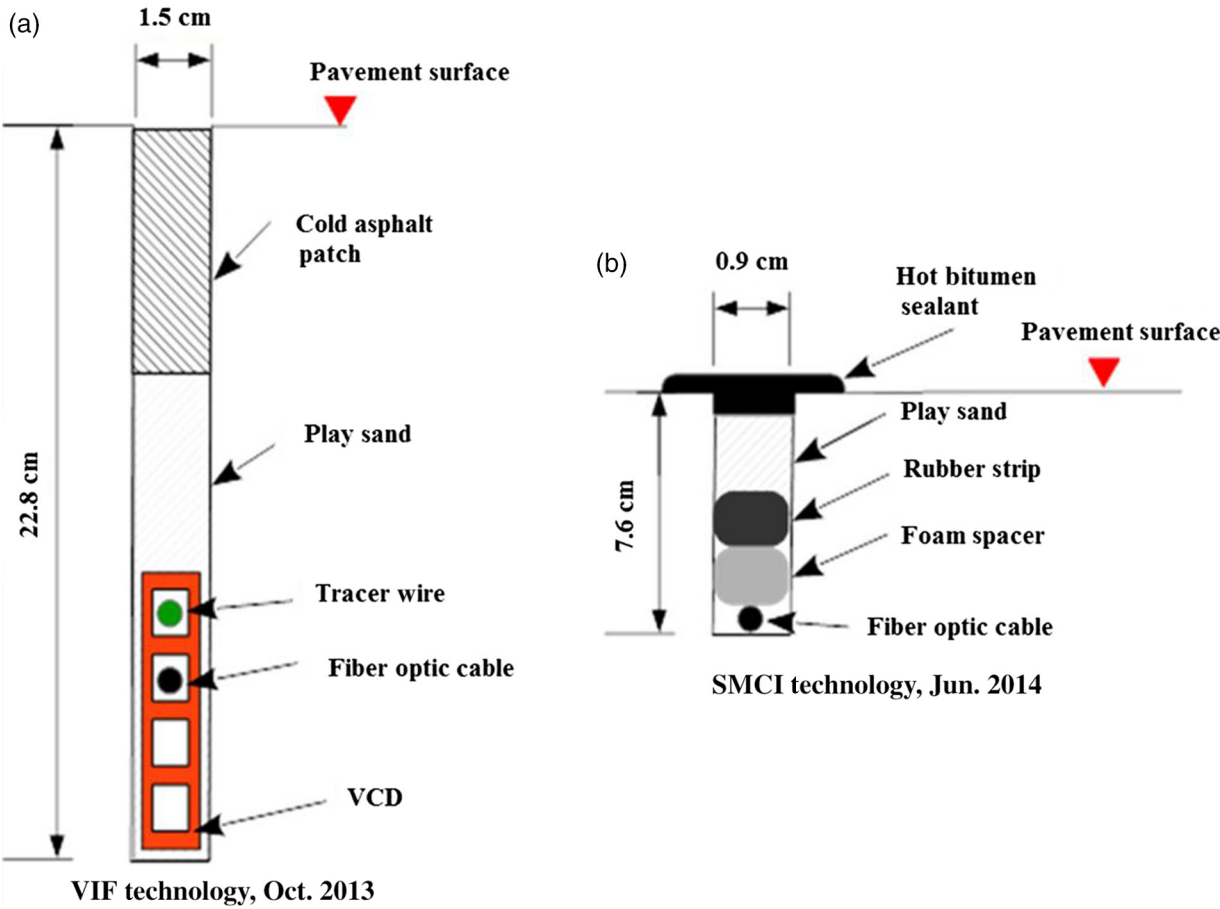
Fig. 3. Cross section of (a) vertical inlaid fiber (VIF) and (b) surface micro-cable inlay (SMCI) installations.

Installation specifications for the VIF technology and a cross section of the SMCI technology are provided in [Table 1](#) and [Fig. 3](#), respectively.

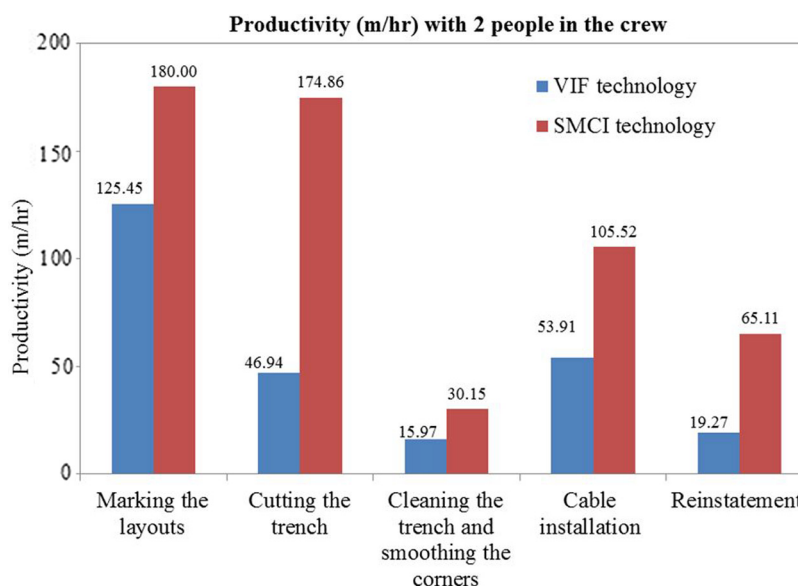
Fig. 4. Productivity rates in both fiber optic (FO) installation technologies.

Figure 4 represents the measured productivity of each micro-trenching activity for both installation technologies using a two-person crew. For both technologies, marking the layout had the highest productivity rate among all activities, whereas cleaning the trench had the lowest productivity rate because it was the most time-consuming activity. Furthermore, the productivity rates of SMCI technology were significantly higher than VIF technology, which was due to the shallower depth of SMCI installations. Shallower depth results in less waste material, less required reinstatement material, and easier creation and reinstatement of the trench. The total micro-trenching productivity associated with VIF and SMCI technologies with a two-person crew was 6.2 and 14.4 m/h, respectively, and considering an 8-h workday, productivity rate was approximately 50 and 115 m/d, respectively. In total, the productivity of SMCI technology was approximately two times that of VIF technology. It should be noted that as the estimated productivities are only based on two pilot installations, they are not representative of micro-trenching productivity in general; however, the information could be valuable for comparisons with other micro-trenching techniques.

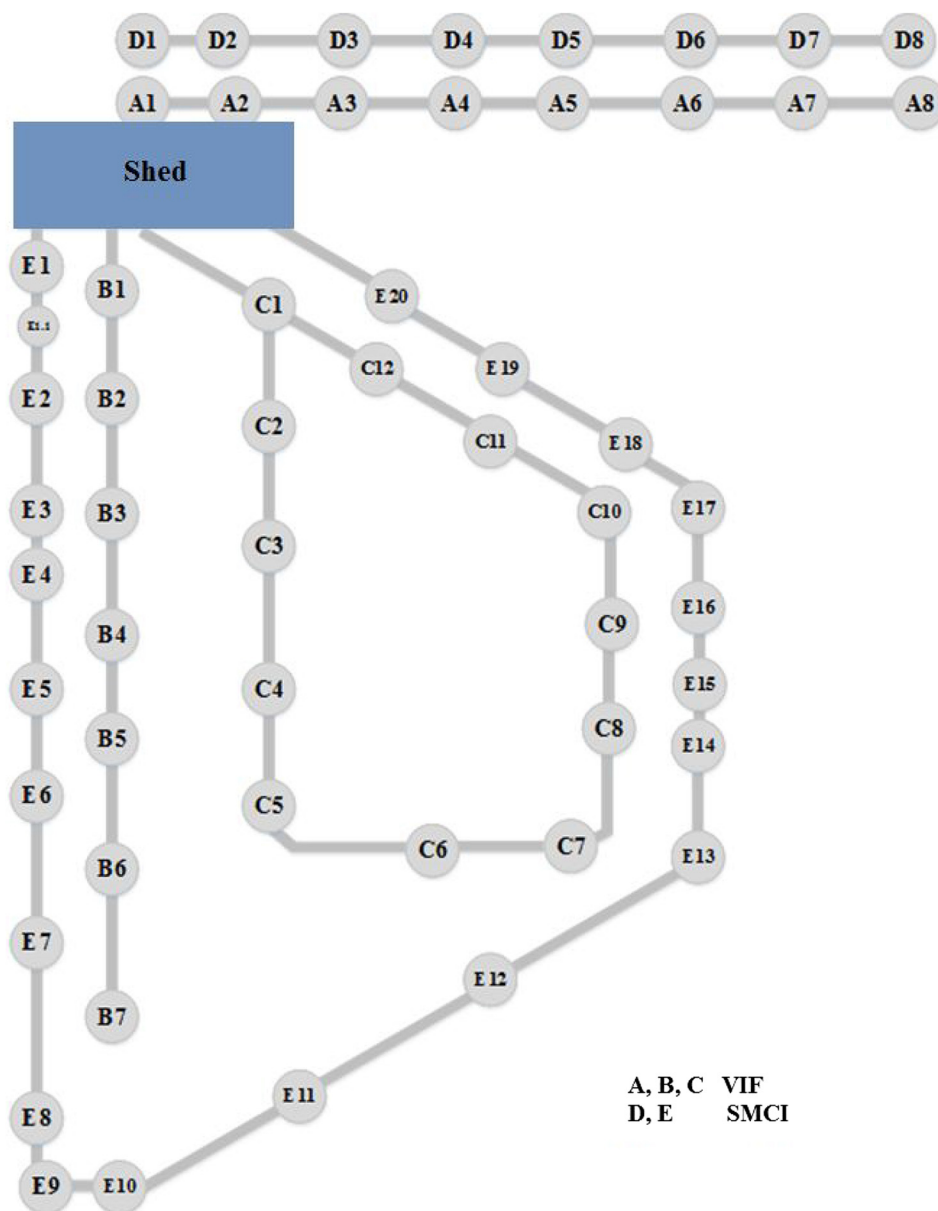
Fig. 5. Ground-penetrating radar-inspected points in vertical inlaid fiber (VIF) and surface micro-cable inlay (SMCI) installations.

In VIF technology, the tracer wire, inserted in the channels of VDC, is a copper-coated wire used to make the conduit more detectable by GPR when determining the location and its movement. To monitor the primary location of the conduit in the micro-trench after each installation, the first GPR inspections were conducted one month after the installations were completed. To investigate the effect of freeze/thaw cycles on the conduit movement, GPR inspections were continued after each winter. Figure 5 shows the GPR-inspected points in both the VIF and SMCi installations on 8 November 2013, 12 May 2014, 30 July 2014, and 4 May 2015.

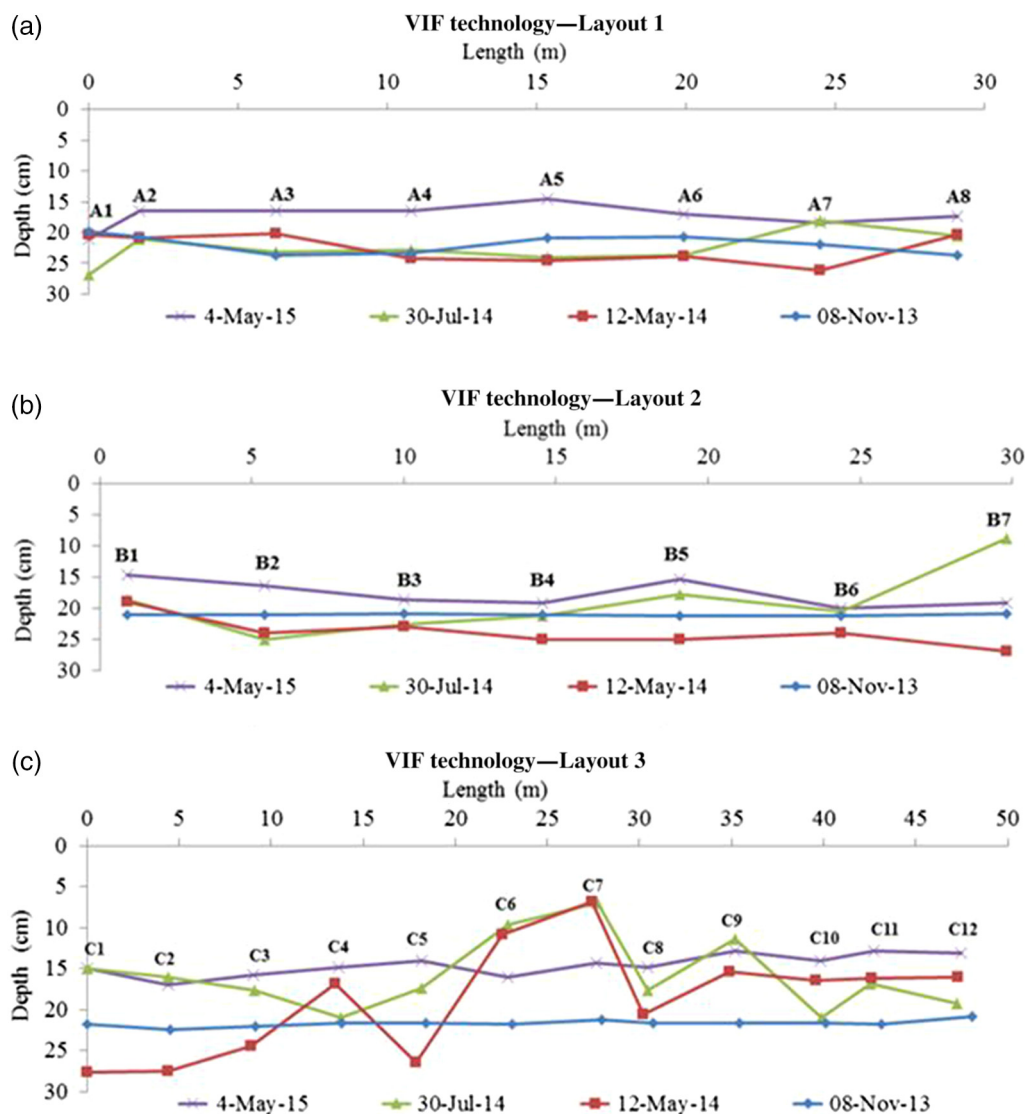
Fig. 6. Conduit profile for vertical inlaid fiber (VIF) technology: (a) Layout 1(A), (b) Layout 2(B), and (c) Layout 3(C).

To investigate the physical integrity of the installation, conduit location was detected using GPR. **Figures 6a–6c** show the conduit profile of Layouts 1(A), 2(B), and 3(C) for VIF technology. It must be noted that the conduit profile was obtained using its depth relative to the surface. In Layout 3(C), the loop is unfolded, and the conduit profile is provided. Points C5, C7, and C10 were located in the bends of the layout (the intersection of straight lines).

Figures 6a and **b** show that both Layouts 1 and 2 were in relatively good condition with little vertical displacement toward the surface, except at point B7, which had a shallow depth of 8.8 cm according to

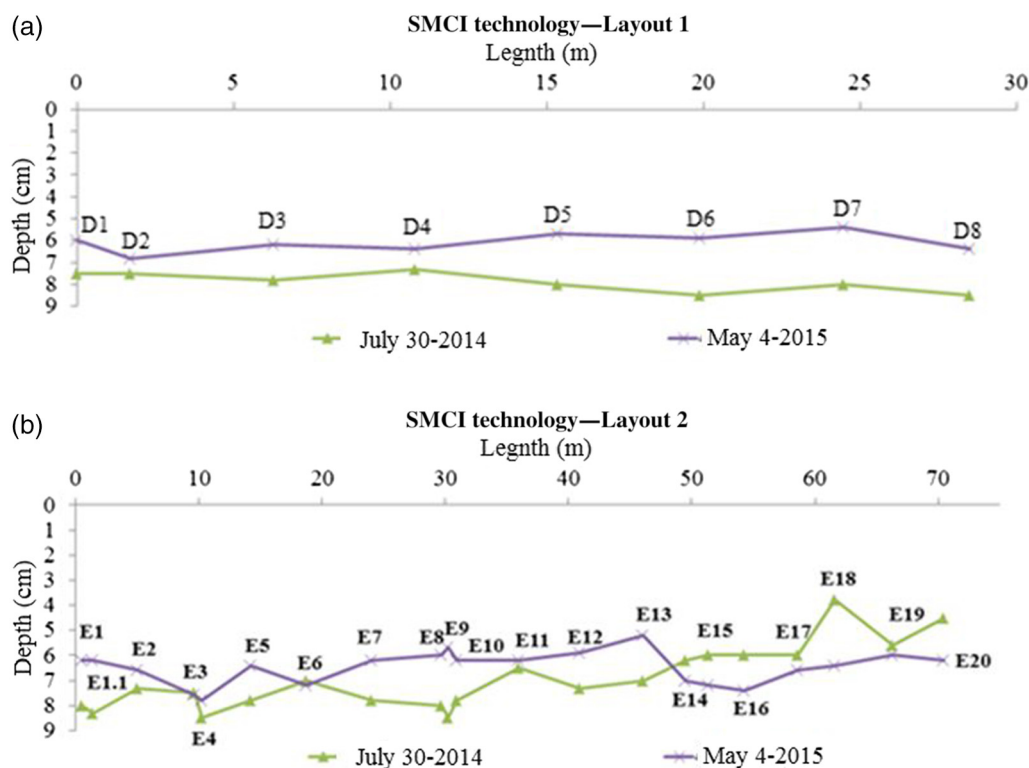
Fig. 7. Conduit profile for SMCI technology: (a) Layout 1(D) and (b) Layout 2(E).

Figures 7a and **b** show the conduit profile of Layouts 1(D) and 2(E) for SMCI technology. It must be noted that the conduit profile was obtained using its depth relative to the surface. In Layout 2(E), the loop is unfolded, and the conduit profile is provided. Points E9, E10, E13, and E17 were located in the bends of the layout (the intersection of straight lines).

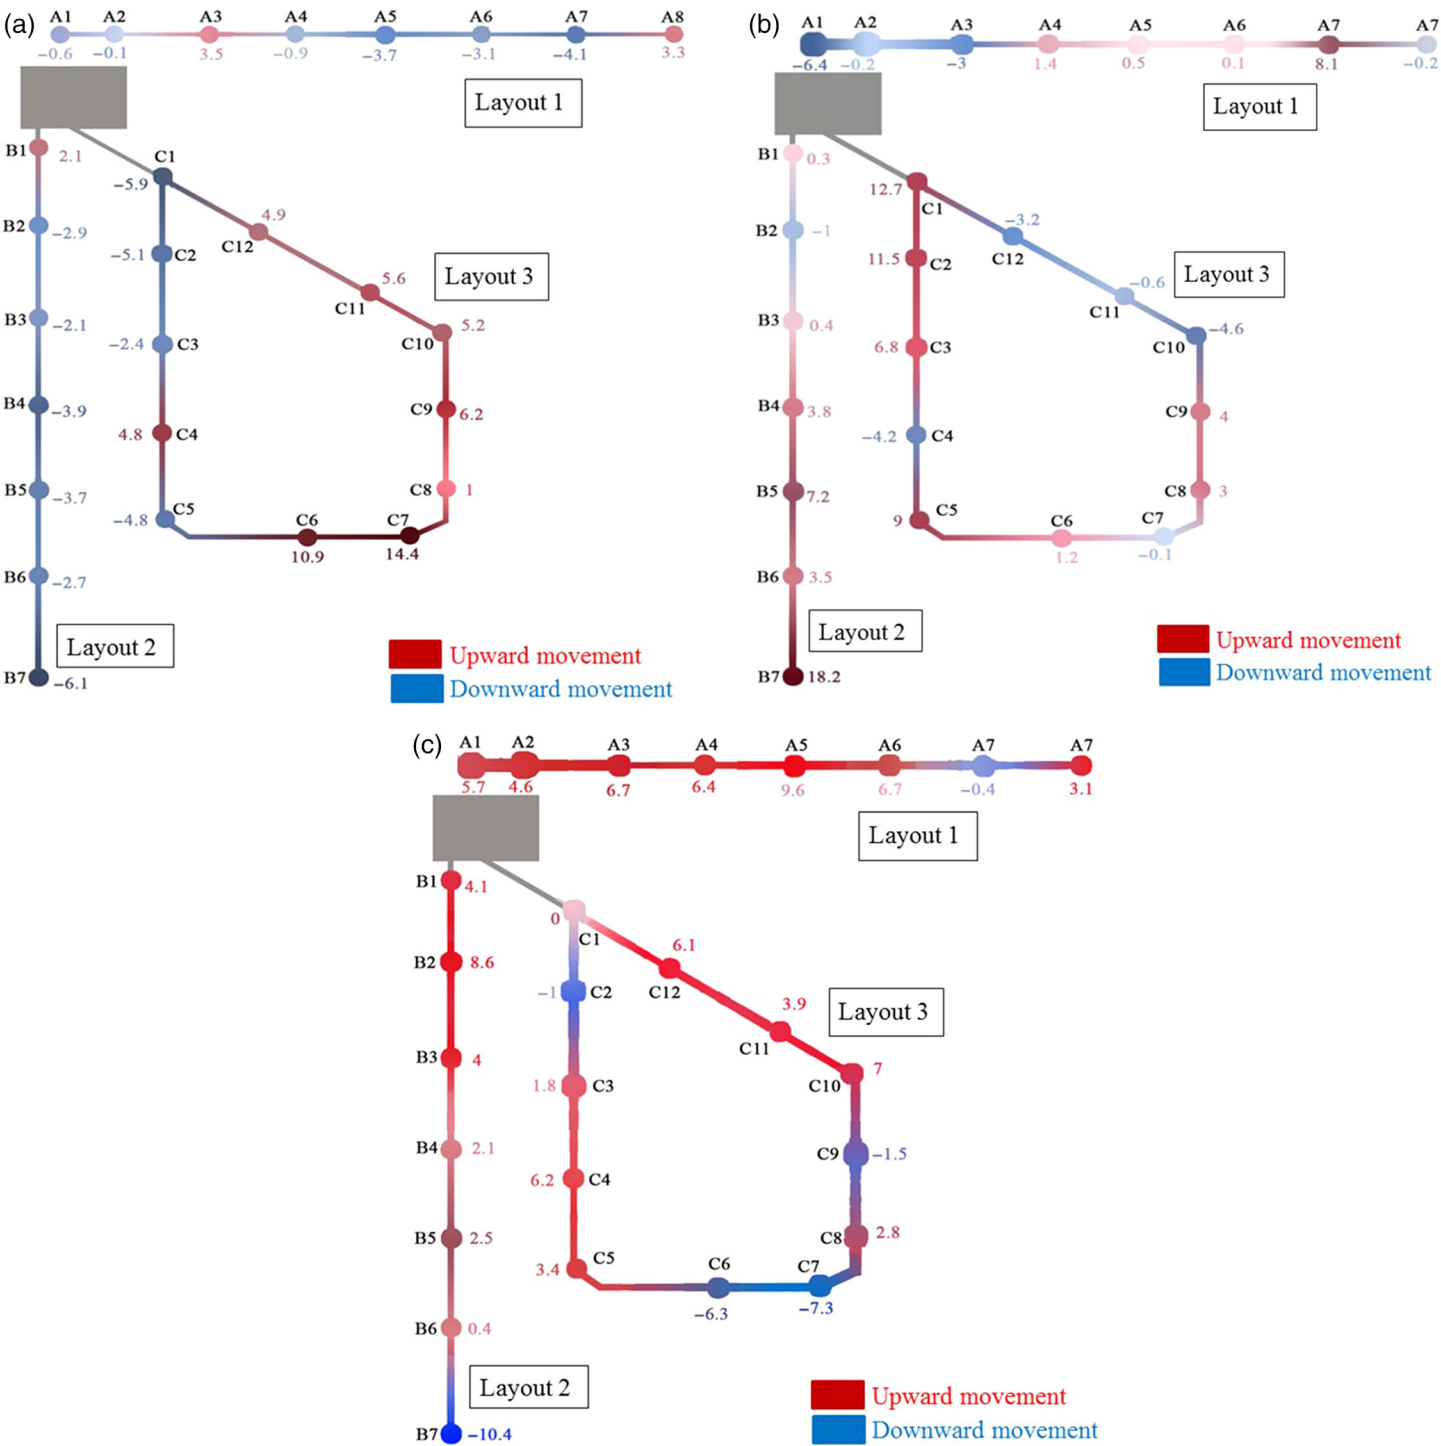
Fig. 8. Conduit location variation relative to surface for vertical inlaid fiber technology: (a) November 2013 to May 2014 (winter), (b) May 2014 to July 2014 (summer), and (c) July 2014 to May 2015 (winter). –, downward movement of the conduit; +, upward movement of the conduit.

Figures 8a–8c and **9** show the seasonal movement of the conduits for both the VIF and SMCI installations from November 2013 to May 2014 (winter), May 2014 to July 2014 (summer), and July 2014 to May 2015 (winter). Negative signs indicate downward movement of the conduits, whereas positive signs indicate upward movement, both of which were measured in centimeters.

In the VIF installations in winter 2014 (**Fig. 8a**), Layouts 1(A) and 2(B) experienced downward movements of up to 6 cm, with the exception of points A3, A8, and B1. The straight section of the loop layout (C) experienced the same movement, with the exception of C4. Conversely, C10–C12 had upward movements of approximately 5 cm. In addition to A3, A8, B1, and C4, these points followed a different trend due to conduit rigidity. When a portion of the conduit rose toward the surface, the other sections sank to maintain conduit stability. In addition, the northeast corner of the loop layout (C6, C7, C8, and C9) had lifted significantly toward the surface.

In the summer of 2014 (Fig. 8b), conduit in Layouts 1(A) and 2(B) moved toward the surface, most significantly at B7 with an upward movement of 18 cm; however, A1 and A3 in Layout 1 experienced downward movements of 6 and 3 cm, respectively. The straight section of Layout 3(C) experienced similar conditions, with an upward movement of 6–12 cm toward the surface at all points except C4. The conduit had little movement in C6 and C7 as maximum movement occurred in winter, and the asphalt layer impeded further upward movement. C10 through C12 and C4 moved downward in response to upward movement in other sections of the loop due to conduit rigidity and stability maintenance.

In winter 2015 (Fig. 8c), Layouts 1(A) and 2(B) moved toward the surface up to 9.6 cm, except at point B7, which had a downward movement of 10 cm. In addition, in Layout 3(C), the conduit moved upward up to 7 cm, except at points C6 and C7, which had a downward movement of 6 and 7 cm, respectively. Points C6 and C7 had the shallowest depths according to the July 2014 GPR inspection.

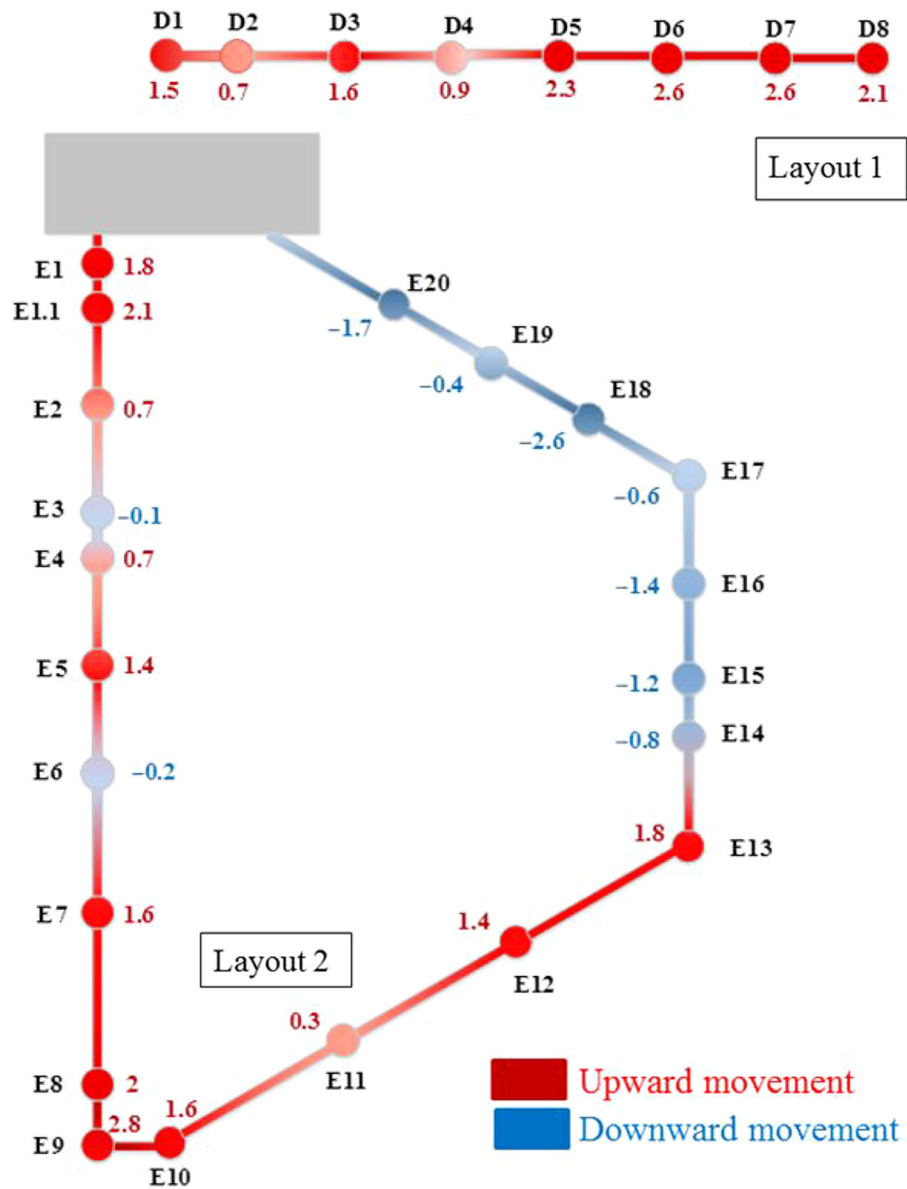
Fig. 9. Conduit location variation relative to surface for surface micro-cable inlay technology: July 2014 to May 2015 (winter). –, downward movement of the conduit; +, upward movement of the conduit.

In the SMCI installation in winter 2015 (Fig. 9), Layout 1(D) and the straight section of Layout 2(E) moved toward the surface up to 2.8 cm. However, the other section of the loop Layout 2(E) had a slight downward movement up to 2.6 cm.
